# Manhole Inspection Summary

Manhole # S1900\_027MH

Insp Date: **7/5/07 10:19 AM**

**Location** Address: **2002 BRYANT-WHITTIER**

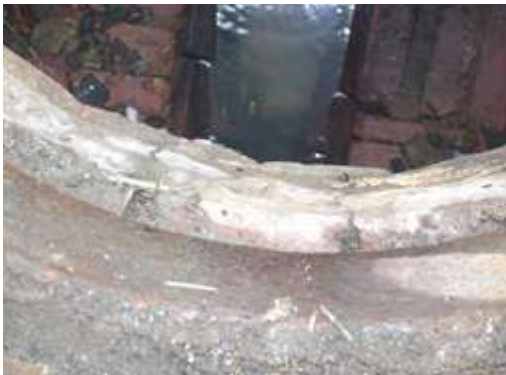
Defect 3

Condition: ☒ Sound ☐ Cracked ☐ Root Intrusion ☐ Deteriorated ☐ Leaks ☐ Debris

Debris on bench and channel

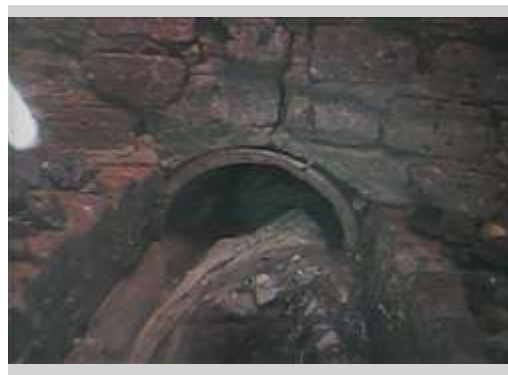
Defect 2

Offset: **1** (in.)

Offset frame

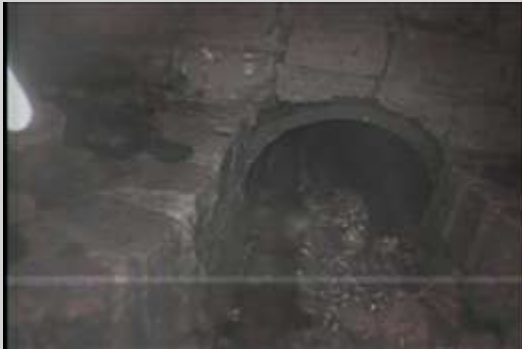
12 O'Clock Outflow

Pipe Height: **7.2** (in.) Rod and Bar (Angled)  
Pipe Material: **Clay** ☐ Pipe Lined  
Invert Depth: **6.50** (ft.) Flow Characteristics: **Slow**  
Deposits: ☐ None ☐ Mud ☐ Sludge ☒ **Debris** ☐ Grease  
Silt Depth: **3** (in.) Deposits Extent: **Medium**  
Infiltration: **None** Pipe Seal Cond: **Sound**

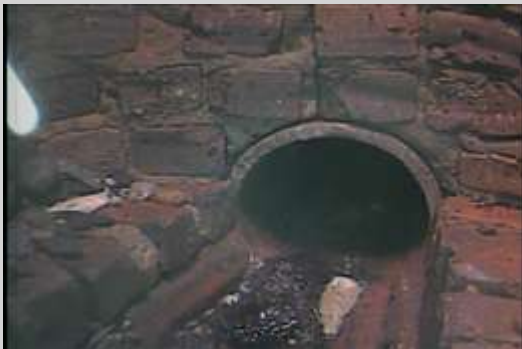
3 O'Clock Inflow

Pipe Height: **8.4** (in.) Rod and Bar (Angled)  
Pipe Material: **Clay** ☐ Pipe Lined  
Invert Depth: **6.03** (ft.) Flow Characteristics: **Slow**  
Deposits: ☒ **None** ☐ Mud ☐ Sludge ☐ Debris ☐ Grease  
Silt Depth: (in.) Deposits Extent:  
Infiltration: **None** Pipe Seal Cond: **Sound**

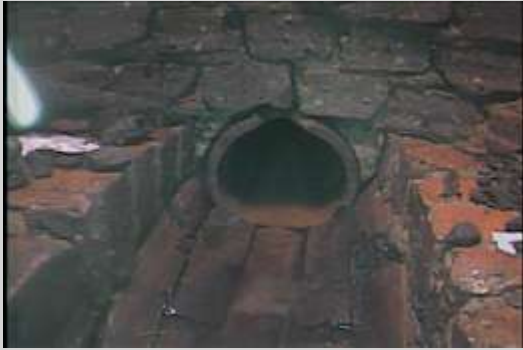
6 O'Clock Inflow

Pipe Seal Cond: **Broken**

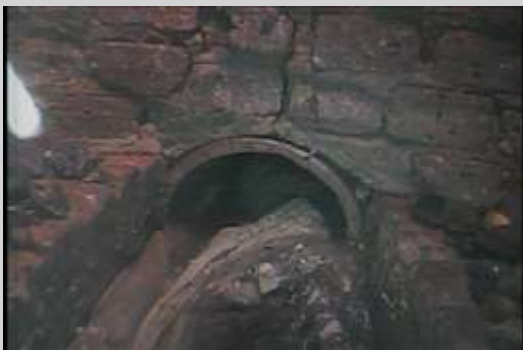
9 O'Clock Inflow

CRACKED BARREL ABOVE PIPE

Deposits: ☐ None ☐ Mud ☐ Sludge ☒ **Debris** ☐ Grease

Silt Depth: **6** (in.) Deposits Extent: **Heavy**
